Failure Analysis of Boiler Tubes

Iskenderun Iron & Steel Co. Iskenderun/Hatay- Turkey

Boiler pipes have important uses in steam and power generating plants. These pipes work with long life in hot thermal conditions. Damages that may occur in pipes cause serious losses such as cost loss and plant downtime. In this study, microstructure analysis was done for possible damages in boiler pipes operating under hot conditions.

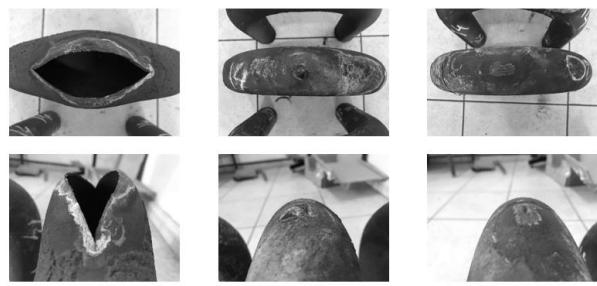
Picture 1 – Macro photos of damaged pipe regions

(1) pipe that has been exposed to prolonged overheating and then torn as a result of severe overheating, (2) and (3) thermal oxidation and beginning to tear

In sample 1, the type of cleavage, defined as “fish mouth”, was observed in the convex portion of the damaged pipes, approximately 200 mm long in the longitudinal direction. Spots like yellow-white color were observed in the rupture region from edge to the ends. A significant decrease in wall thickness was noted on the torn surfaces.

In sample 2, there was an swelling in the bending region of the pipe and a crack of approximately 20 mm in length in the longitudinal direction. In addition, there are white-yellow spots from the crack to the outside.

In the sample 3, swelling and cracking were also determined in the twist zone.

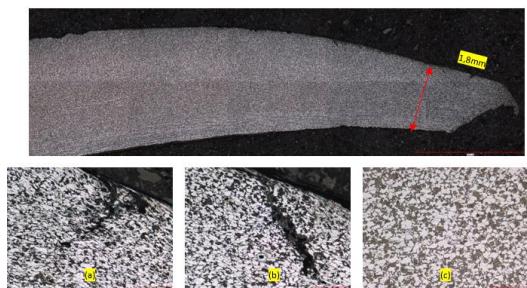
In the area close to the rupture point, crevations forming determined from the outer surface to inner. It was found that the wall thickness decreased to 1,8 mm near the tearing surface. (**Picture 2**).

Picture 2 - Microstructure photos of tearing area
(a) and (b) crack formation and deformed grain orientation on the surface, (c) microstructure of the defect free zone.

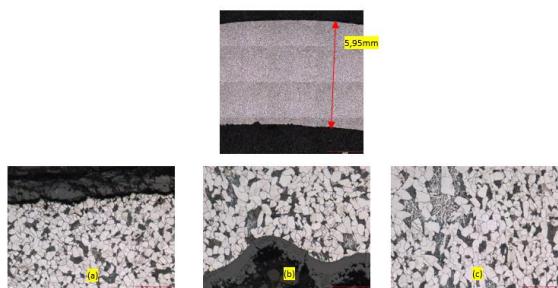
Iron oxide compounds in the cracks were determined by SEM EDS analysis. Intergranular gap formation was also noted. In the region of the opposite wall of the damaged surface, the cavities in the inner wall and the formation of the scaling layer caused by thermal oxidation covering them were observed. The wall thickness measured 5,95 mm. (**Picture 3**)

Picture 3 - Cross-sectional view of the opposite region of the tear
(a) and (b) oxide layers on the inner and outer surface of the pipe section. (c) Matrix ferrite, perlite microstructure and degenerated perlite

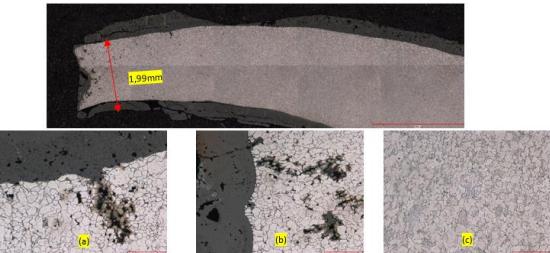
In the sample, the wall thickness was decreased to 1,99 mm in the area close to the crack. (Picture 4). Increasing of intergranular gap formation was observed in the regions close to the rupture point. There is supportive literature data that cavities can occur as a result of uneven sliding of grains in the structure under high temperature and stress conditions, also known as creep.

Picture 4 - Microstructure photos of tearing area
(a) and (b) intergranular corrosion starting from the outer surface in the pipe section. (c) Ferrite and carbide structures of the area

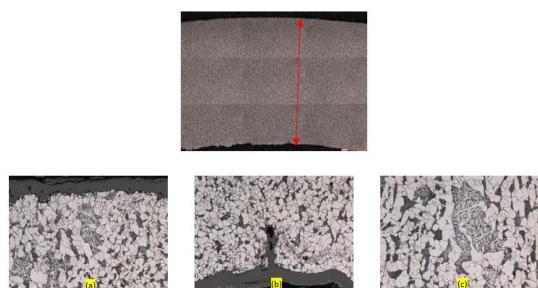
In the SEM examination of the sample taken from the opposite wall of the cleaved region, a pit with a depth of approximately 90 μm was observed and scale layer was observed. (**Picture 5**)

Picture 5 - Cross-sectional views of the opposite region of the tear
(a) ferrite, perlite and degenerated perlite structures of the outer pipe surface; (b) Thermal oxidation and pitting corrosion on the inner surface of the pipe.

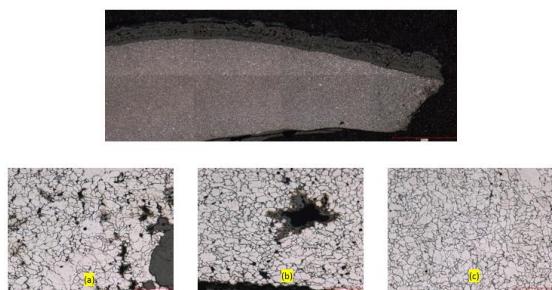
In the examination of the damaged surface section, ferritic grain structure was observed and scaling was observed in the inner and outer walls and in the intergranular spaces (**Picture 6**). In the section taken from the opposite wall, the ferritic-perlitic structure was seen. The pit formation and scales were identified on the outer and inner surface (**Picture 7**).

Picture 6 – Microstructure of the teared surface
 (a) and (b) Intergranular corrosion and intergranular space formation in the pipe section. (c) Ferrite and carbide structures

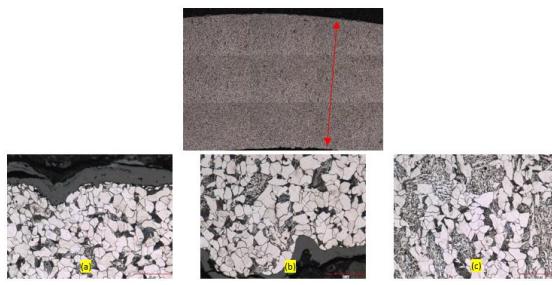
Picture 7 - Cross-sectional images of the opposite region of the tear
 (a) Thermal oxidation, ferrite, perlite and degenerated perlite structures of pipe outer surface
 (b) thermal oxidation at the inner surface of the pipe. (c) Ferrite, perlite microstructure and degenerated perlite
