Prevention of leaks in hot air line valves at Isdemir 4th blast furnace stoves

Iskenderun Iron & Steel Co. Iskenderun/Hatay- Turkey

In this study, stoves used in heating the air blown to the blast furnace in Iskenderun Iron and Steel Co. (ISDEMİR) in 4th blast furnace are examined by using pattern instead of welding method in order to eliminate leakages in the valves on the side of the hot air line of the stoves. The new implementation started in June 2019.

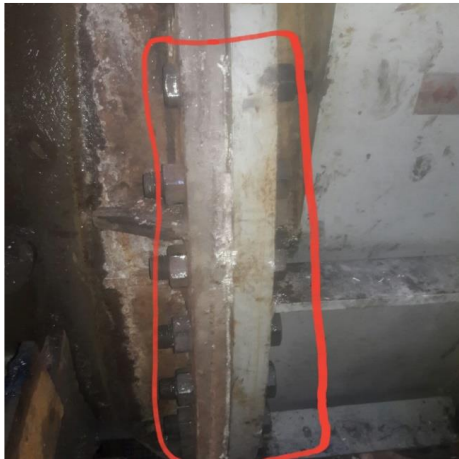
Figure 1. Leak area that is tried to be removed by welding

In order to eliminate leaks occurring in the hot air line connection valves of the stoves, the 4th Blast Furnace had to reduce the production speed or stop. After proper working conditions were ensured, the welding process was applied to the leaked area if it could be covered with illegal welding. If a seal change is required, the furnace is stopped and the seal is replaced. All these operations caused production losses. These procedures for removing leakage are shown in **Figure 7**.

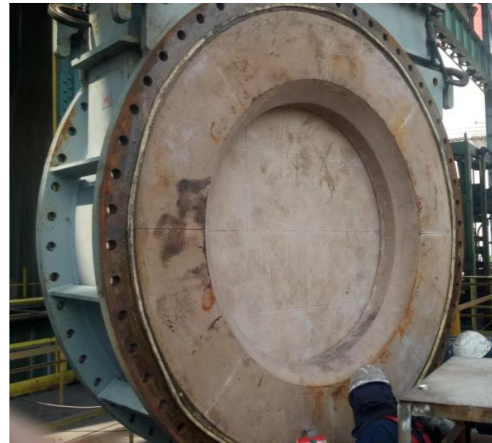
Figure 3: Valve to be assembled

The valves that connect the stoves with the hot air line are technically manufactured according to DN1700 standards. The surfaces of these valves that come into contact with the hot air line are covered with special refractory bricks. The valves have a system which operates with chain mechanism and the tongue in the valve can move up and down. With the commands given by the blast furnace control room, the movement of the tongue in the valve is provided and hot air passes into the furnace. On the inner surface of the valves, there are lines that pass cooling water against heating. These lines are responsible for providing heat transfer in the valves. These valves are shown in **Figure 3**.

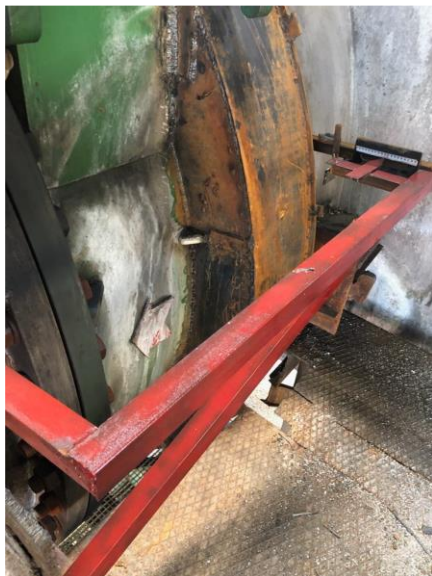
Figure 2. Circular pattern

See *Figure 1*, with the new method that is being implemented, a circular pattern is placed on the flange regions without welding to the leaked areas and concrete is poured into the interior of the pattern and leaks are eliminated. This situation shown in *Figure 2*.

frequently caused leaks that caused production to stop. Finally, a pattern were prepared to surround the flange areas that were leaked and concrete was poured into the pattern to prevent leaks. Pattern application and concrete pouring photos are given in **Figure 8**.

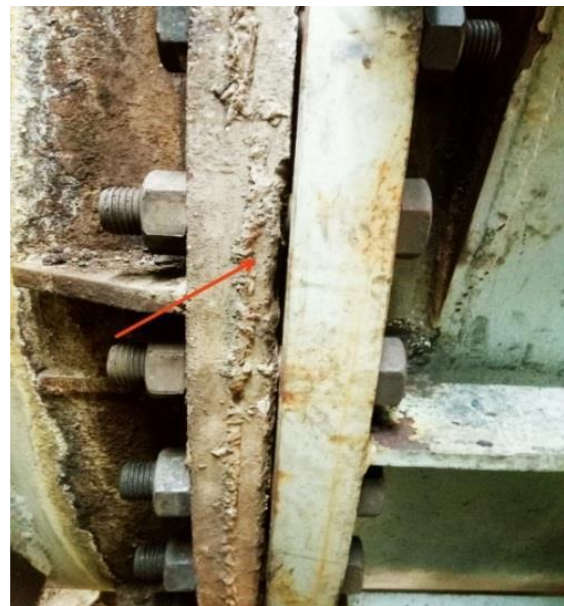
There are some factors that cause gas leaks. These factors are axial mismatches in the flanges at the connection points of the valves between stoves, leakages caused by seals and wear of refractory material in valve. Figure 4 shows the leakage at the flange connection points of the valves. **Figure 5** shows the time-related damage to the refractory material.

Figure 4: Leakage from the flange connection areas of the valves

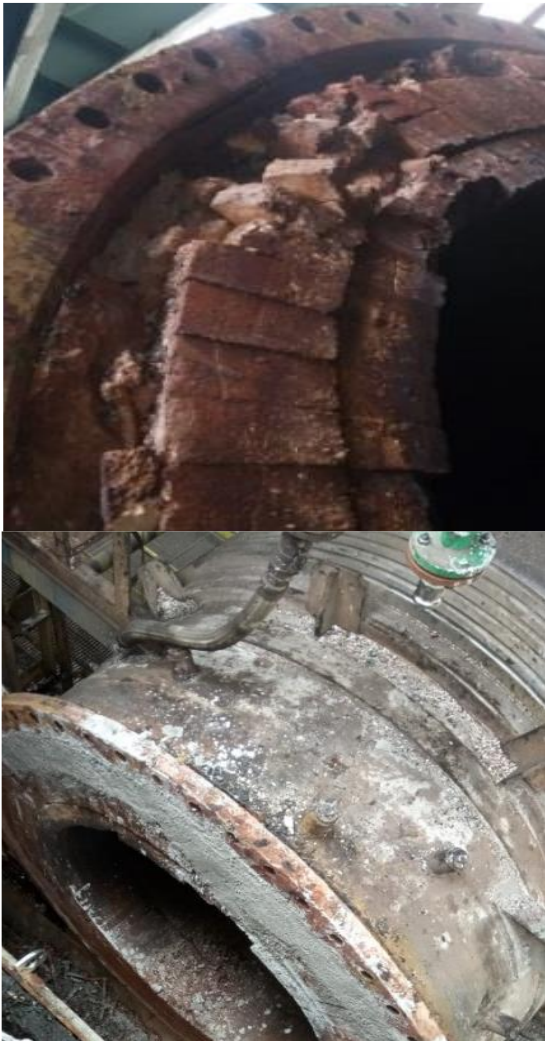
Figure 5: Wear of refractory materials in flanges areas

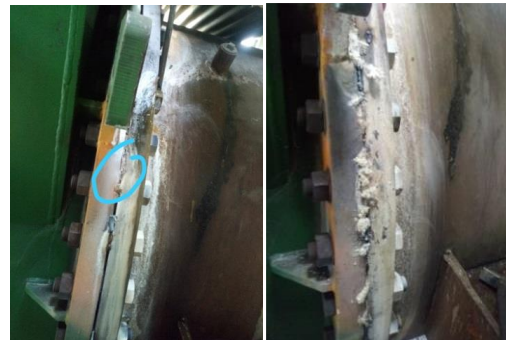
Figure 7: Seal and welding applications in the flange regions of the valves

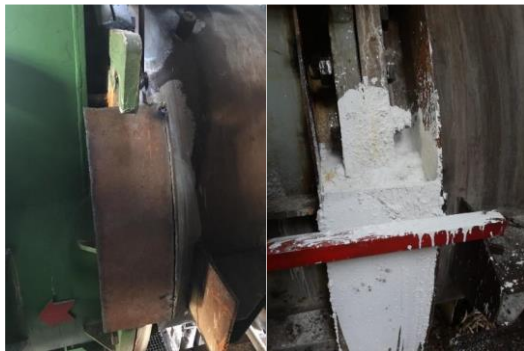
Figure 8: Flange areas of valves are molded with pattern and concrete is poured into pattern

AL95 has been selected as the concrete to be used and properties of poured AL95 concrete are given in **Table 2** and **Table 3**

As a result of the concrete pouring application which started to be applied against the leakages occurring in stove valves in İSDEMİR 4th Blast Furnace, there was not appeared leakage that would decrease production speed for 5 months regime with while it is inactivated beyond threshold voltage. The extracted threshold voltage and the electric field mobility were also found to be thermally activated.
